NBS BUILDING SCIENCE SERIES 77

# Acoustical and Thermal Performance of Exterior Residential Walls, Doors and Windows

*1105*  
Hale J. Sabine and Myron B. Lacher

Daniel R. Flynn and Thomas L. Quindry

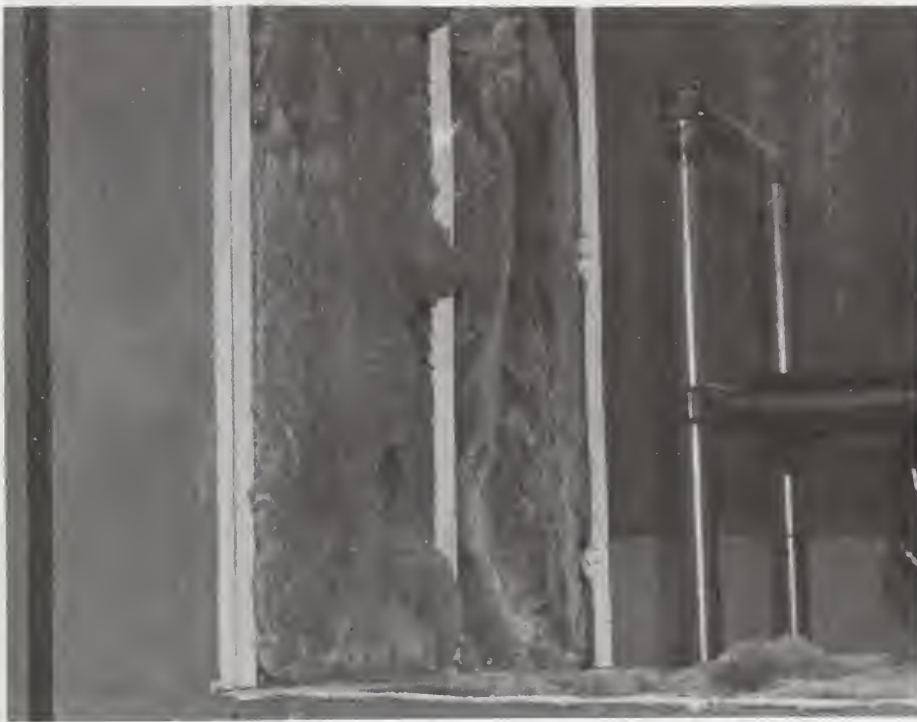
Figure B-1. Filler wall after cutting opening for picture window.

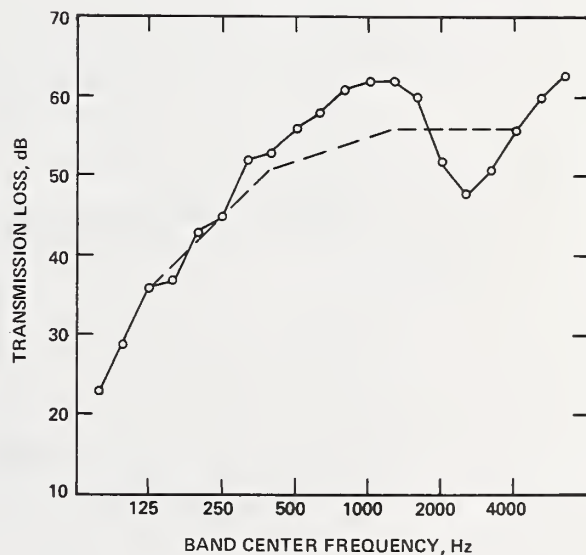
Figure B-2. Sound transmission loss vs frequency data for wood stud drywall with resilient channel and cavity insulation.

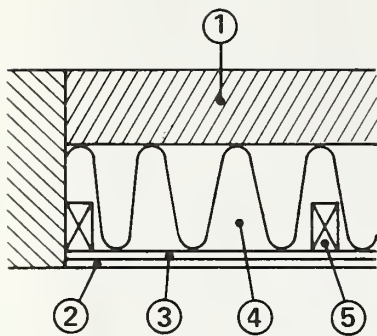
1. RESILIENT CHANNEL DRYWALL  
(SEE FIGURE 2, W-1-71)
2. 1/2 IN. GYPSUM BOARD
3. 5/8 IN. GYPSUM BOARD
4. FIBERGLAS BUILDING INSULATION
5. 2 IN. x 4 IN. STUDS 16 IN. O.C.

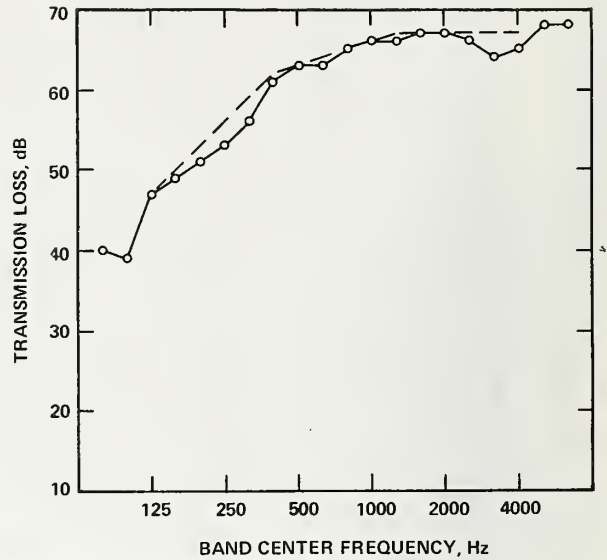
Figure B-3. Apparent sound transmission loss vs frequency data for complete filler wall, concrete surround not covered.

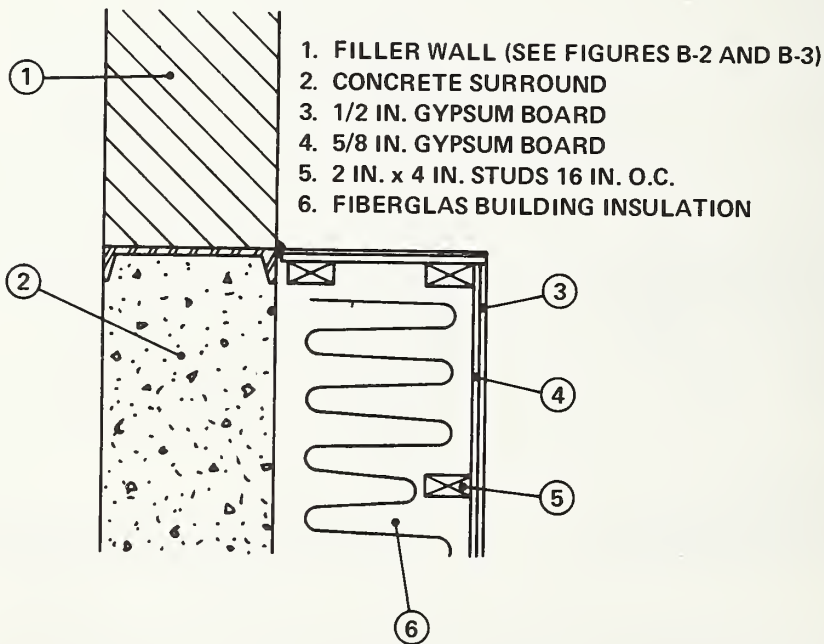
1. FILLER WALL (SEE FIGURES B-2 AND B-3)
2. CONCRETE SURROUND
3. 1/2 IN. GYPSUM BOARD
4. 5/8 IN. GYPSUM BOARD
5. 2 IN. x 4 IN. STUDS 16 IN. O.C.
6. FIBERGLAS BUILDING INSULATION

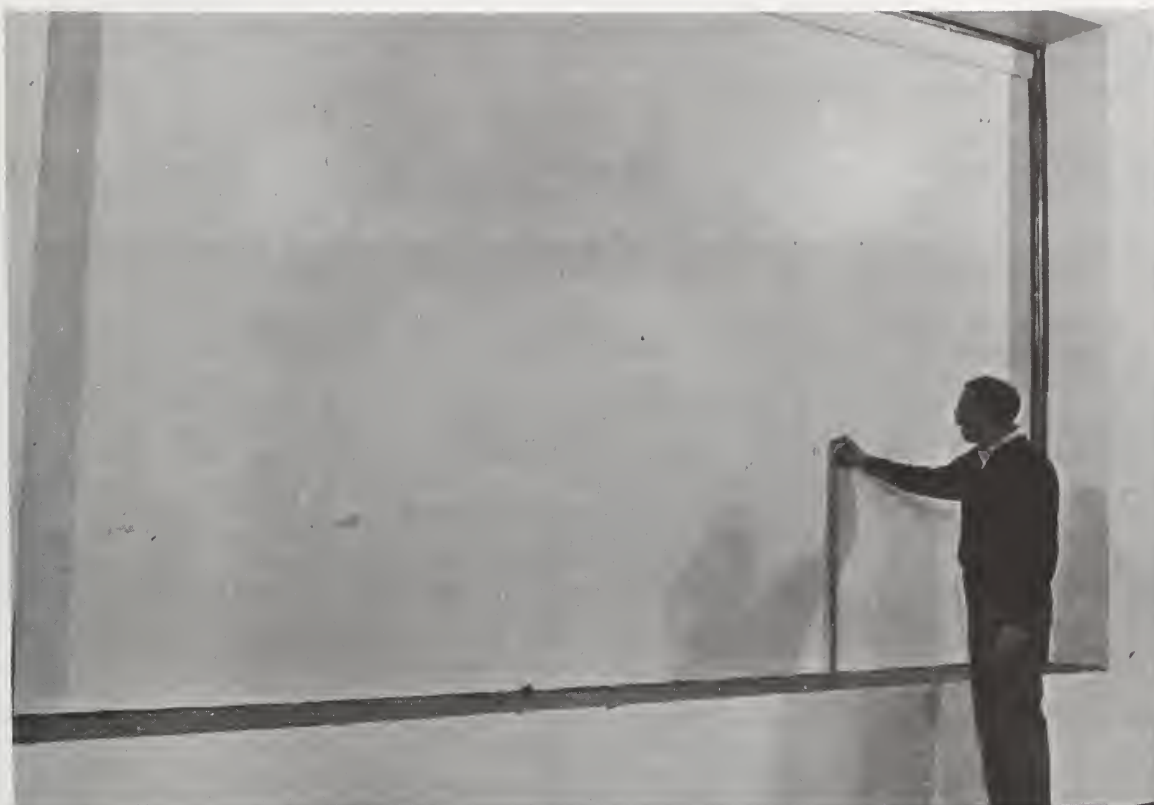
Figure B-5. Filler wall and auxiliary construction over concrete surround.

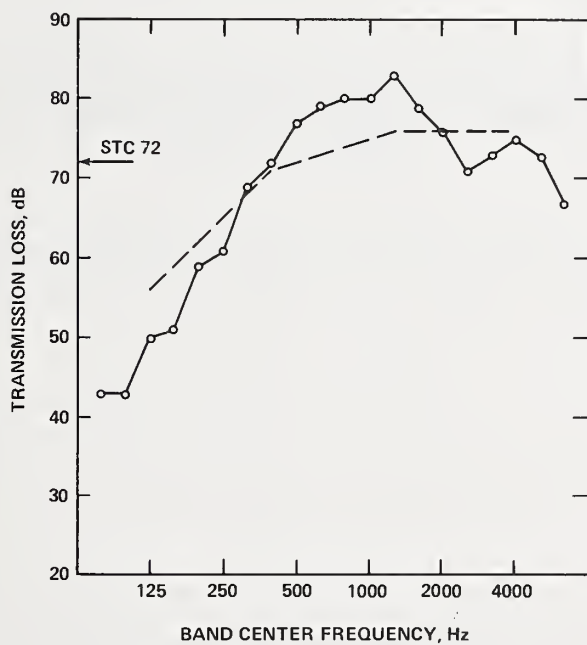
Figure B-6. Apparent sound transmission loss vs frequency data for complete filler wall with auxiliary construction added to concrete surround.

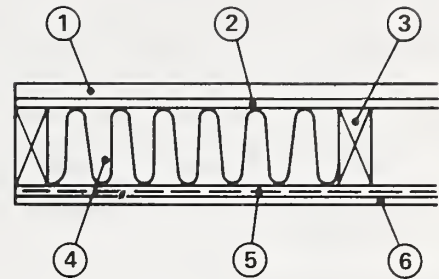
1. 5/8 IN. x 10 IN. REDWOOD SIDING
2. 1/2 IN. INSULATION BOARD SHEATHING
3. 2 IN. x 4 IN. WOOD STUDS 16 IN. O.C.
4. FIBERGLAS BUILDING INSULATION (W-54-71 AND W-55-71 ONLY)
- 3 IN. PREMIUM BRAND PAPER ENCLOSED BUILDING INSULATION (W-5-72 ONLY)
- ALFOL TYPE 2P REFLECTIVE-TYPE INSULATION (W-6-71 ONLY)
- 3 1/2 IN. FIBERGLAS FRICTION FIT INSULATION (W-7-72 ONLY)
5. NATIONAL GYPSUM RESILIENT CHANNEL (W-55-71 AND W-56-71 ONLY)
6. 1/2 IN. GYPSUM BOARD SCREWED TO CHANNEL

Figure C-4. Detail of wood-siding, wood-stud exterior walls.
